WINTER ISLAND PARK

City of Salem, Massachusetts

Site Assessment Memorandum

June 28, 2024

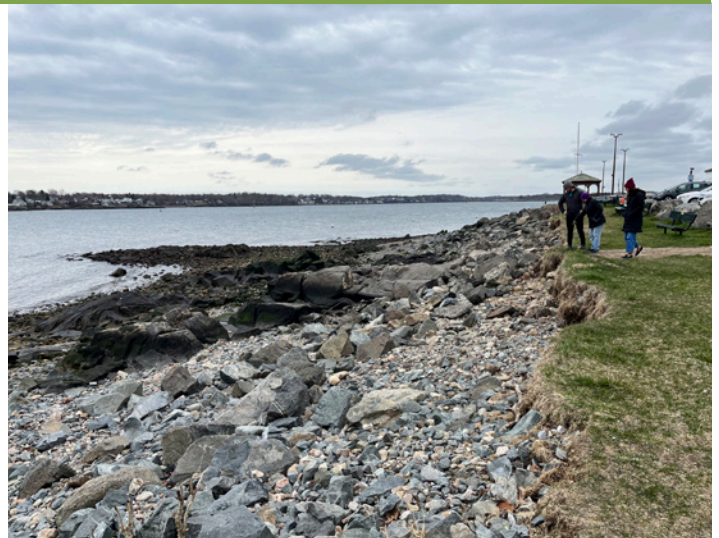
Parking Lot Edge

The primary parking area for the Park is located to the southeast of the island. The parking area serves daily visitors to the Park, as well as RV campers during the summer season. An approximate twenty-foot wide mown grass strip extends along the east facing length of the parking lot from the existing gazebo to the headland that comprises the outer wall of Fort Pickering. This grass strip houses underground utilities for campers and contains multiple seating benches and a gazebo at the southern end. The seaward edge of the grass strip has become severely undercut in the winter storms of 2024. The foundation of the gazebo is also becoming undermined.

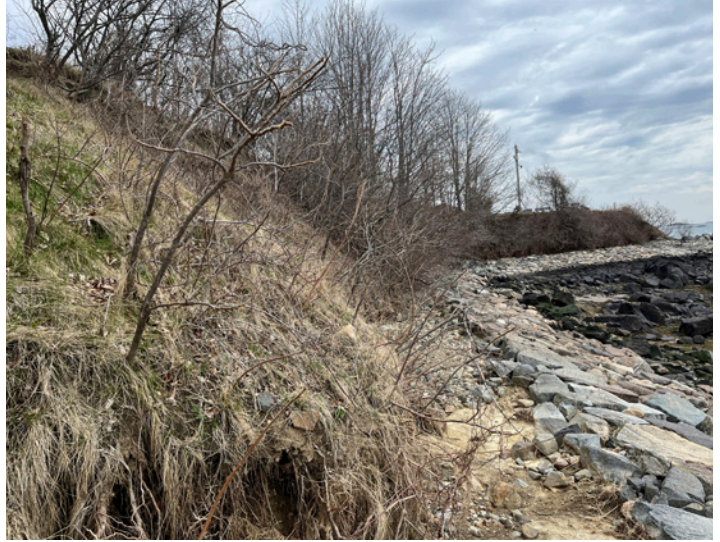
Southern Shoreline

The southern shore of the headland is a steep, heavily invaded Coastal Bank fronted by a shallow grade revetment that extends seaward from the bottom of the bank. A pathway that once allowed foot traffic access up the bank to the elevated earthen rampart that surrounds the Fort has become severely undermined. There is visual evidence that the low-lying revetment has been overtopped by storm surge and is eroding the Coastal Bank in several locations. This erosion, coupled with a predominantly shallow rooted, non-native plant community, creates a condition where the bank is likely to become more unstable over time.

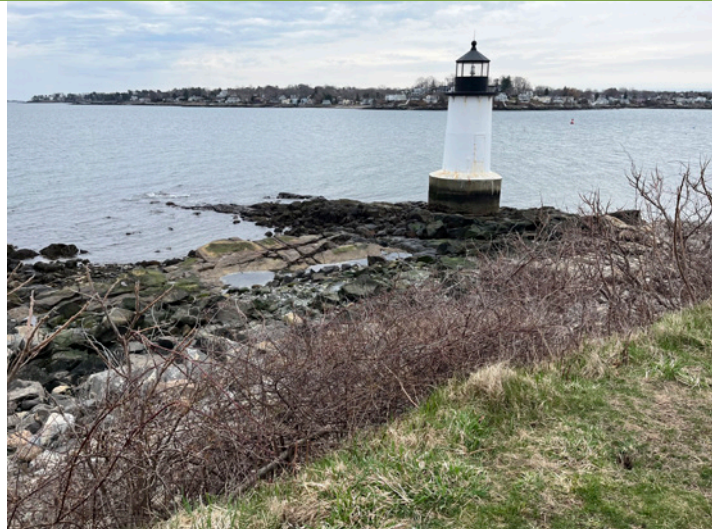
The Headland

The rocky outcrop that forms the point of the headland faces due east/northeast towards the lighthouse. The shallow-grade revetment continues along the shoreline and erosion at the base of the Coastal Bank was also observed in this area. The vegetative matrix on the Coastal Bank in this area is similar to that of the southern shoreline, with a mix of native and non-native plant species. A two-foot wide grass strip extends from the edge of the heavily traversed footpath to the top of the bank. Eroded channels cut down the bank at several points along the headland. The walking path in this area forms the main part of the earthen rampart surrounding the Fort. The Coastal Bank on the northern part of the headland becomes steeper and more undercut with bare, eroding soils readily apparent beneath a dense cover of invasive vines.

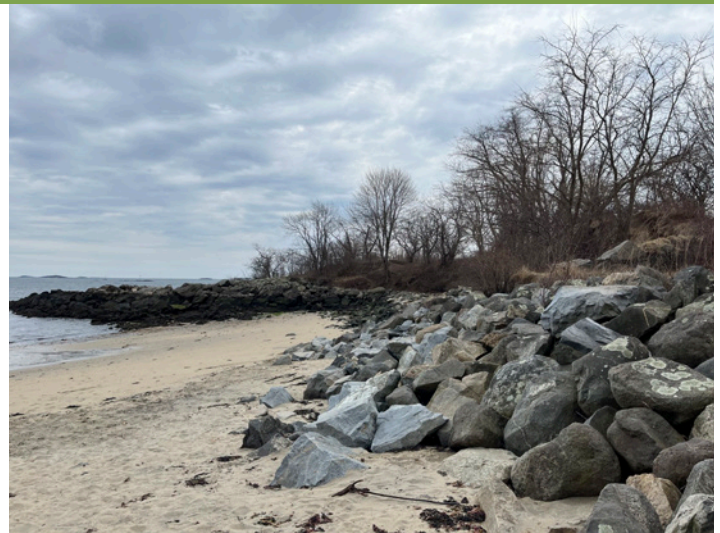
The Coastal Bank forms a crescent around Waikiki Beach with bank heights undulating from high to low in a northerly direction. The sandy arc of Waikiki Beach is backed by naturally occurring ledge on the northwestern end and a degraded revetment at the eastern end. There is an approximate 10' gap between these stones and the bottom of the unarmored Coastal Bank, which is filled with sand and small cobbles. The Coastal Bank itself is significantly eroded in several locations and covered with invasive vines and trees. Many informal foot paths cut down the bank to the beach from the more established path at the top of the bank on the earthen rampart. These informal paths have created significant erosion over time.

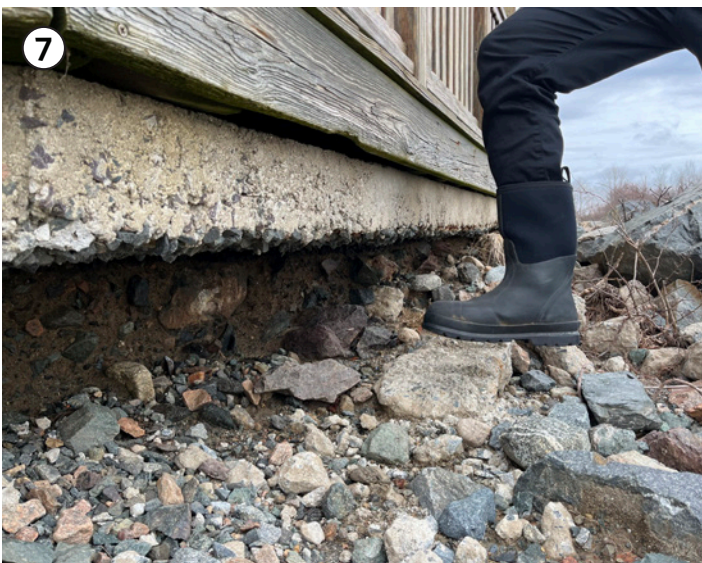
FIGURE 7: SOUTHWEST CORNER OF THE GAZEBO HAS BECOME UNDERMINED

The existing stones that comprise the lower bank have been subject to storm surge and extreme high tides during the winter and spring storms of 2023 & 2024 and will likely offer little protection to the existing parking lot and undermined gazebo foundation (Figure 7) in the near future. The undulating 20' wide grass strip extends from the top of the bank to the edge of the parking lot is also heavily compacted by foot traffic, reducing the likelihood that existing vegetation can withstand the impacts of extreme tidal conditions.

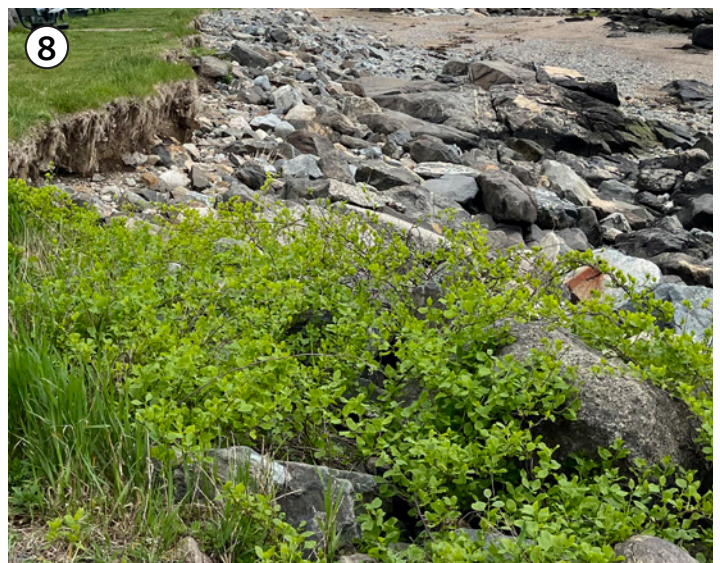
FIGURE 8: ASIATIC BITTERSWEET GROWING AT THE EDGE OF THE COASTAL BANK

There is a limited amount of Asiatic bittersweet (*Celastrus orbiculatus*) growing at the eroded edge of the mown grass strip adjacent to the parking lot and between the revetment stones (Figure 8). It is recommended that Asiatic bittersweet in this area be treated and removed prior to implementing any erosion control strategy so that this invasive plant does not take root in any future erosion control solutions or planting.

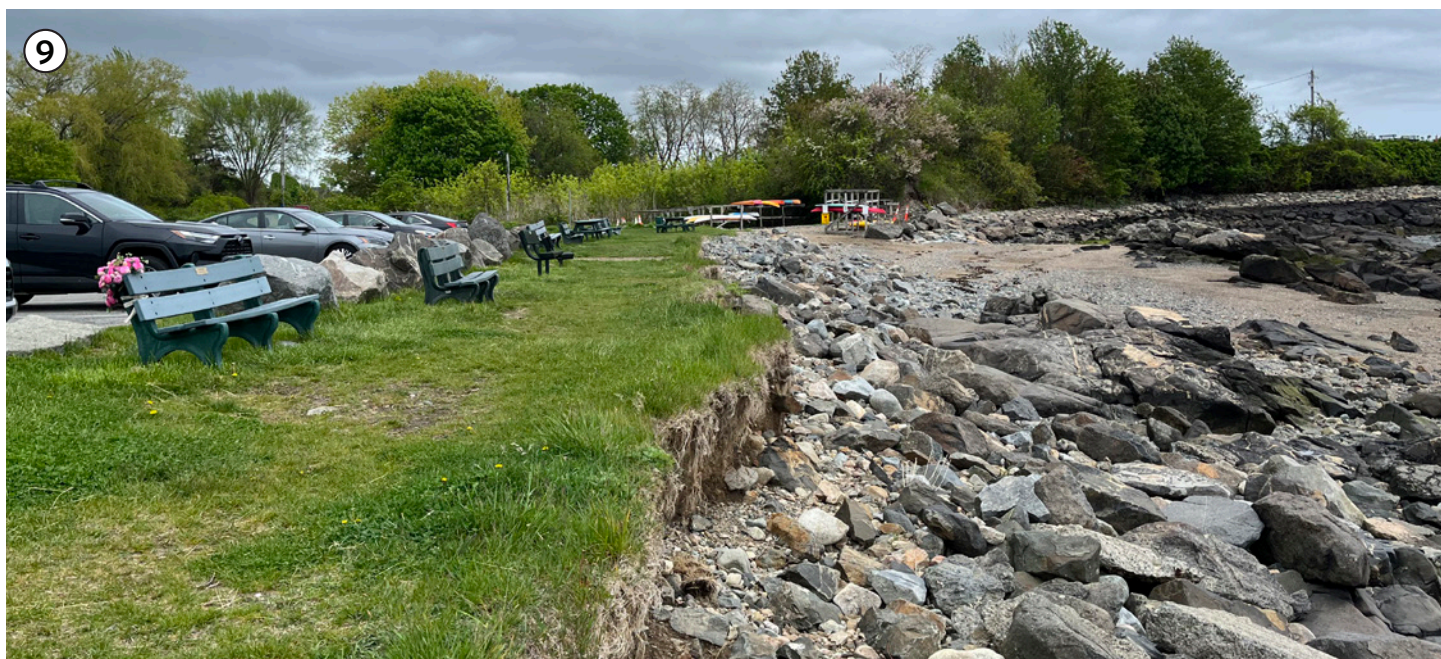
The Coastal Bank that runs the east facing length of the parking lot is undercut at an almost vertical angle. The root systems of the existing turf grass that grows at the top of the bank, and extends to the parking lot edge, are exposed at the seaward edge with sections of the bank having slumped or been completely eroded away (Figure 9).

FIGURE 9: THE STEEPLY ERODED EDGE OF THE COASTAL BANK

The grass species that comprise the mown strip along the parking lot are likely a mix of non-native turf grass and self seeded native grasses. Management recommendations included establishing a no-mow buffer of deep-rooted and salt tolerant native grasses that can hold soils more effectively than shallow-rooted grasses and are more resilient to salt water over-wash. Though this area is well utilized by the public, WED recommends that foot traffic be restricted from as much of this area as possible, while native grasses are establishing. This could be accomplished with the installation of symbolic fencing, or other systems similar to what is used at the nearby Collins Cove salt marsh restoration. Shoreline stabilization measures, other than planting, will likely be required to stabilize and retain the Coastal Bank in this area and to protect the parking lot from future flooding. Planting should be performed in conjunctions with other shoreline stabilization methods that will retain soils until the root systems of the plantings become established.

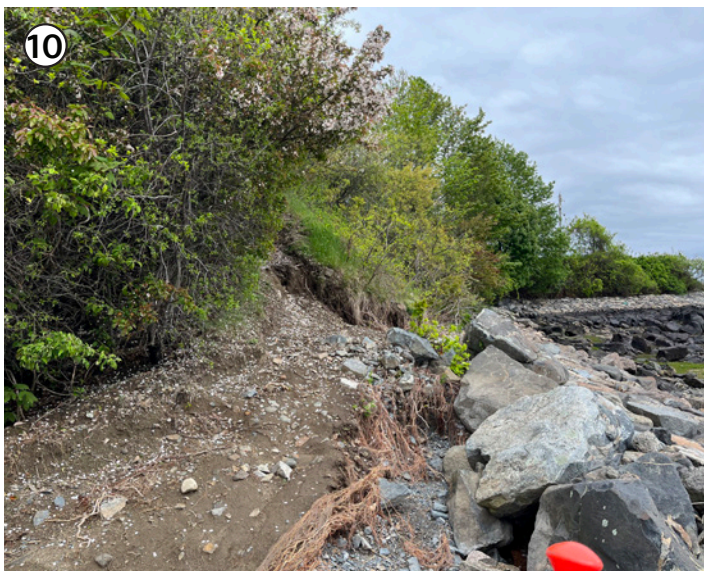
FIGURE 10: BASE OF ERODED PATHWAY

The southwestern corner of the assessment area, just beyond the seasonal kayak rack and existing pathway, is the most heavily eroded portion of this area. The lower half of the pathway and bank has been stripped to bare soils with the exposed roots of Asiatic bitterweet and staghorn sumac trailing onto the lower bank (*Figure 10*). The eroded entrance to the pathway is likely due to a combination of soil compaction from foot traffic and the flooding conditions present during storm events. Portions of the lower bank adjacent to the pathway have begun to slump onto the flat area just above the revetment (*Figure 11*).

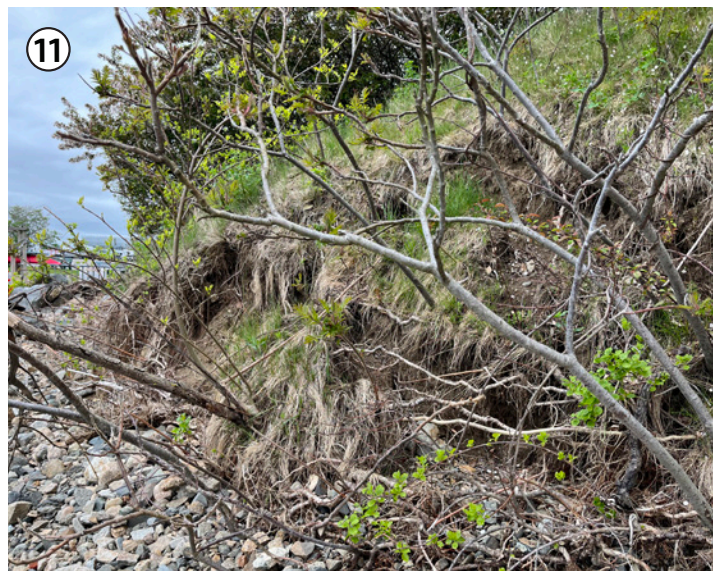
FIGURE 11: SLUMPED SECTION OF COASTAL BANK

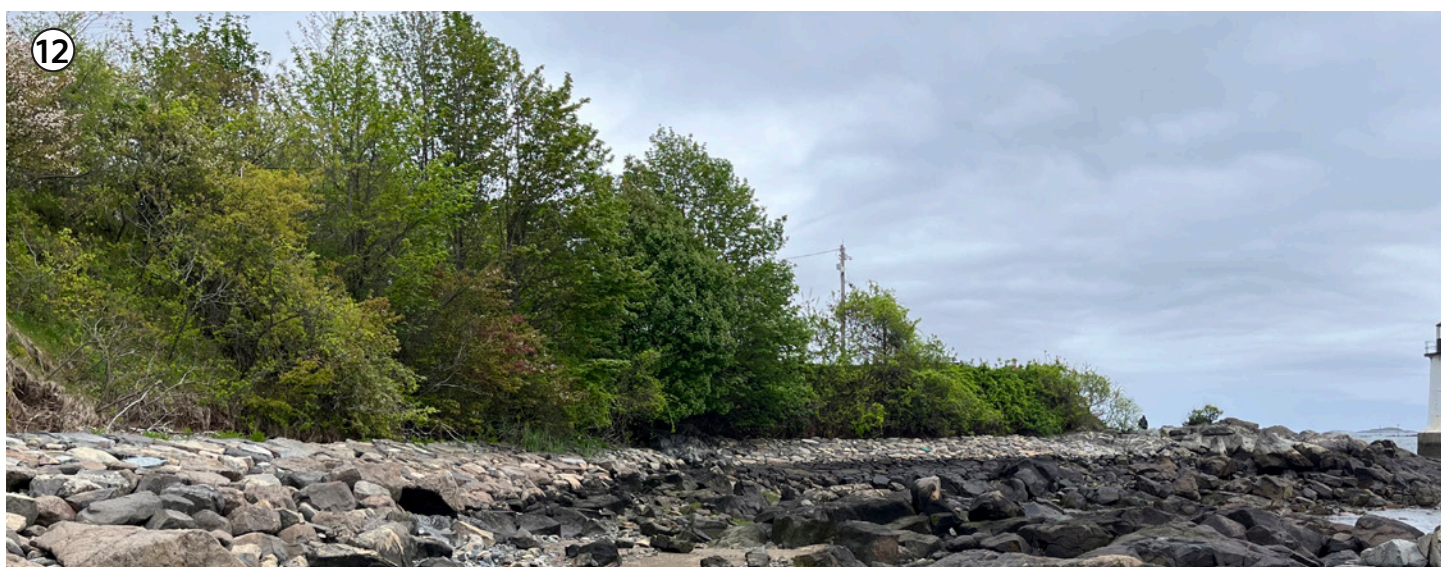
The entire southern shoreline, is heavily invaded with Asiatic bittersweet (*Celastrus orbiculatus*) and sycamore maple (*Acer pseudoplatanus*). Crabapple trees and saplings are present throughout this area but are particularly dense on the western end of the assessment area. Moderate clusters of native staghorn sumac are present near the eroding path from the parking lot and towards the lighthouse point. A ground layer of soil retaining grasses was observed where the sumac is most concentrated and appears almost entirely absent where there is a high density of Asiatic bittersweet and sycamore maple.

FIGURE 12: SOUTHERN COASTAL BANK WITH LARGE SYCAMORE MAPLES TREES

Vegetation management recommendations include the treatment and removal of Asiatic bittersweet from the entire area. Consideration should also be given to the selective removal of Sycamore maple trees (*Figure 12*). Sycamore maple is a significant invasive tree species observed throughout Massachusetts. This species' dense foliage and growth habit can significantly impact native forest understory stratification. Sycamore maple trees spread rapidly at maturity because of the large volume of seeds produced. In addition, Sycamore maple also exudes allelopathic chemicals that inhibit the growth of surrounding vegetation. In addition, large trees on steep banks can destabilize large portions of the bank if they topple. After invasive plant management is complete, planting of appropriate native grasses and shrubs on the bank is critical to establishing the deeply rooted biomass that will help retain bank soils during storm events, and to discourage the re-colonization of invasive and unwanted plants by limiting the resources available to such plants (i.e. sunlight, nutrients, and growing space).

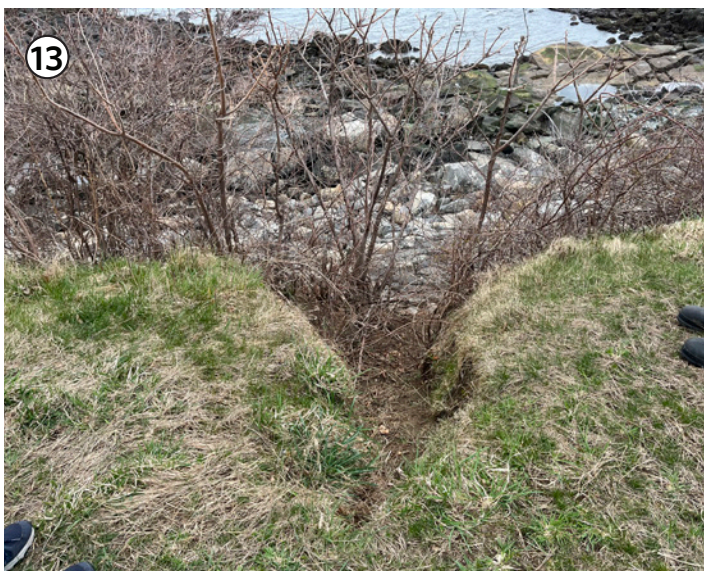
FIGURE 13: ERODED CHANNEL ON THE COASTAL BANK

The shallow revetment continues from the southern shoreline around the point. The Coastal Bank facing the lighthouse is moderately steep with a series of deep, eroded channels extending from the top of the bank to the top of the revetment (*Figure 13*). These channels likely funnel stormwater down the bank during storm events. Soils at the top of the bank are heavily compacted and devoid of vegetation due to intensive foot traffic through this vista point, though the top 1 to 2 feet at the crest of the bank is vegetated with predominantly non-native grasses which likely limits foot traffic in this area (*Figure 14*).

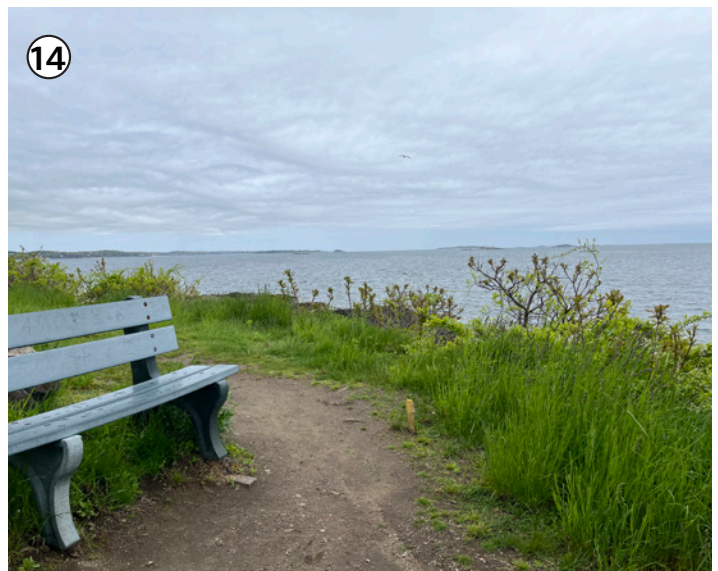
FIGURE 14: COMPACTED FOOTPATH & GRASS EDGE

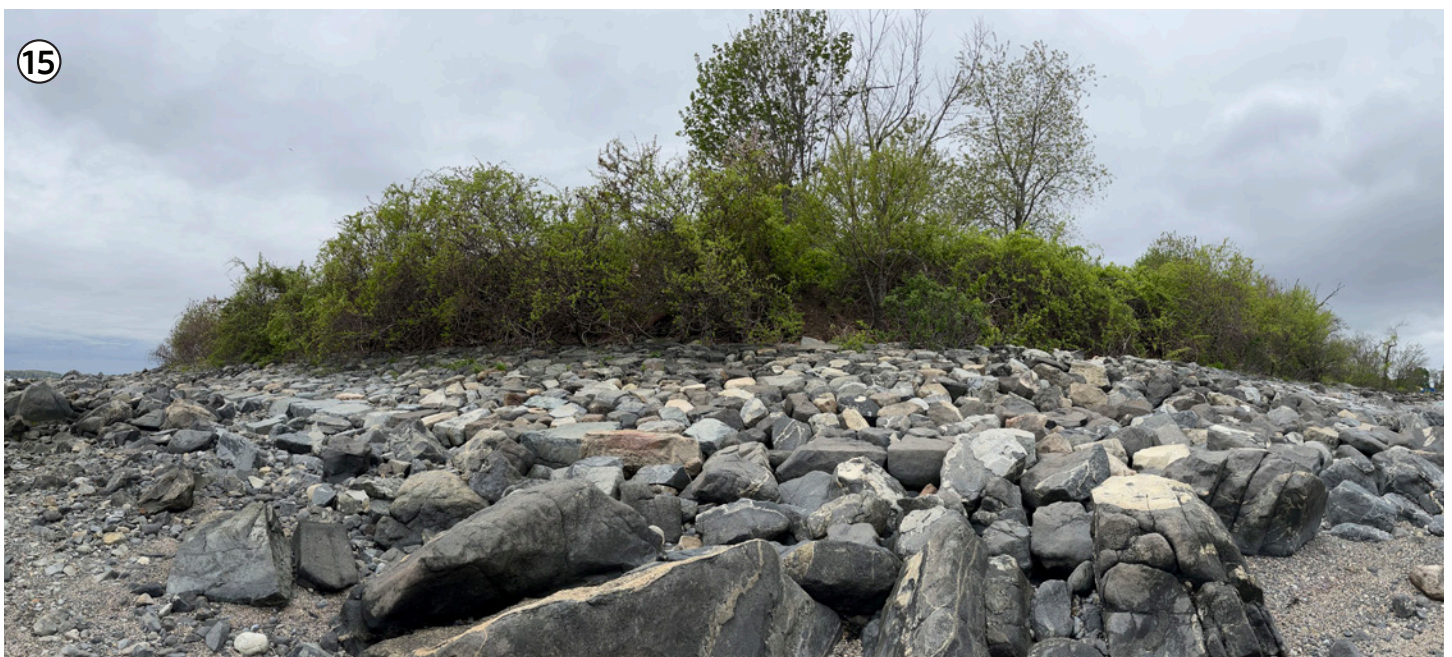
As the shoreline wraps around to the point to the north, the Coastal Bank becomes steeper (*Figure 15*). Bare soils under a dense thicket of invasive vines are present across the whole northern bank, with scarping present at several points across the bank. The wrack line is present just above the revetment at the base of the unarmored bank. A well-worn pathway cuts from the top of the bank to the beach below and a limited amount of herbaceous vegetation was observed to be stabilizing soils at the bottom of the pathway.

FIGURE 15: NORTH FACING COASTAL BANK COVERED WITH INVASIVE VINES

Vegetation management recommendations include the treatment and removal of Asiatic bittersweet from the entire area. Staghorn sumac, while native and a good bank stabilizer, may be a candidate for minimal management if views are to be considered. Management could consist of limited treatment and removal and/or selective pruning of height in key locations. At a minimum, crab apple sapling should be replaced with vegetation that will more effectively hold bank soils in place, like deeply rooted native grasses and salt tolerant shrubs. Pathway edges near the top of the bank should be revegetated to the extent feasible while still leaving adequate room to walk, and pathways that veer too close to eroded areas at the top of the bank, should be pulled landward where there is space to do so.

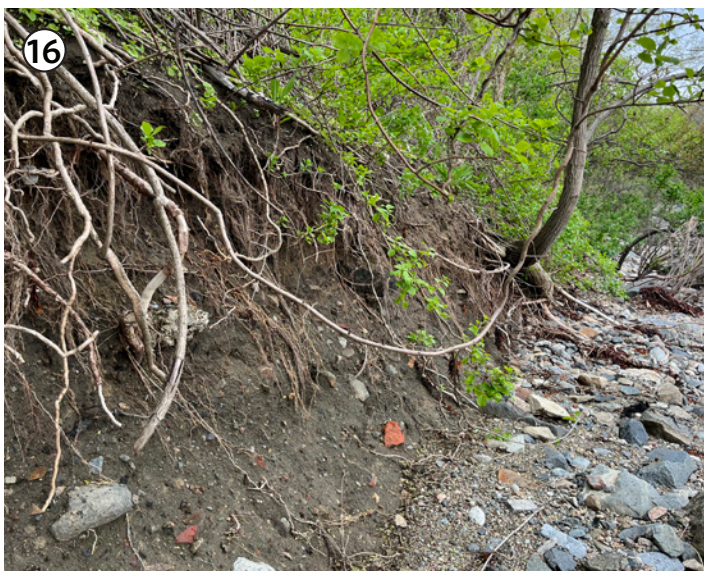
FIGURE 16: ERODED CHANNEL ON THE COASTAL BANK

Bank soils on the southern end are highly compacted, vertical, and devoid of vegetation on the unarmored bank. It is apparent that bank sediment has been washing away over time due to the brick, metal and other artifacts that protrude from the bank or are lying on the beach (Figure 16). Overall the bank in this area is highly vulnerable to erosion from storm events.

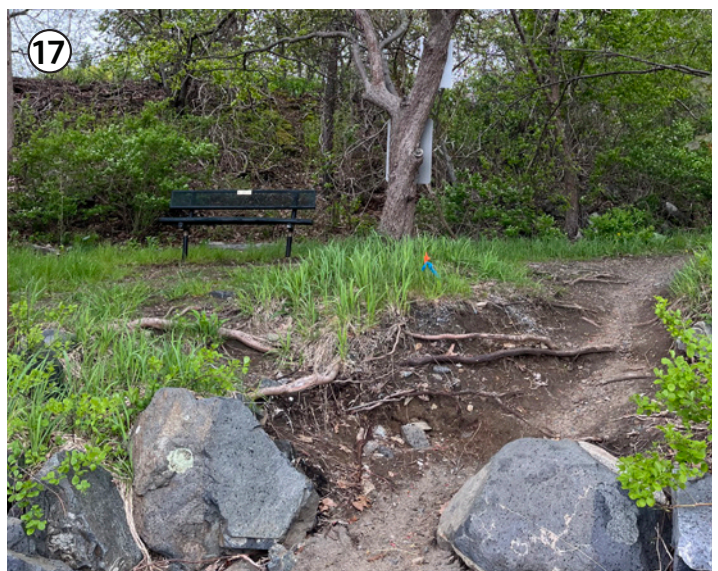
FIGURE 17: COMPACTED FOOTPATH & GRASS EDGE

Erosion on the northern end of the bank is mostly limited to locations where there is heavy foot traffic on the formal and informal pathways (Figure 17). Erosion in these areas is exacerbated by the density of invasive and non-native plants that cover the majority of the bank and do little to hold soils in place.

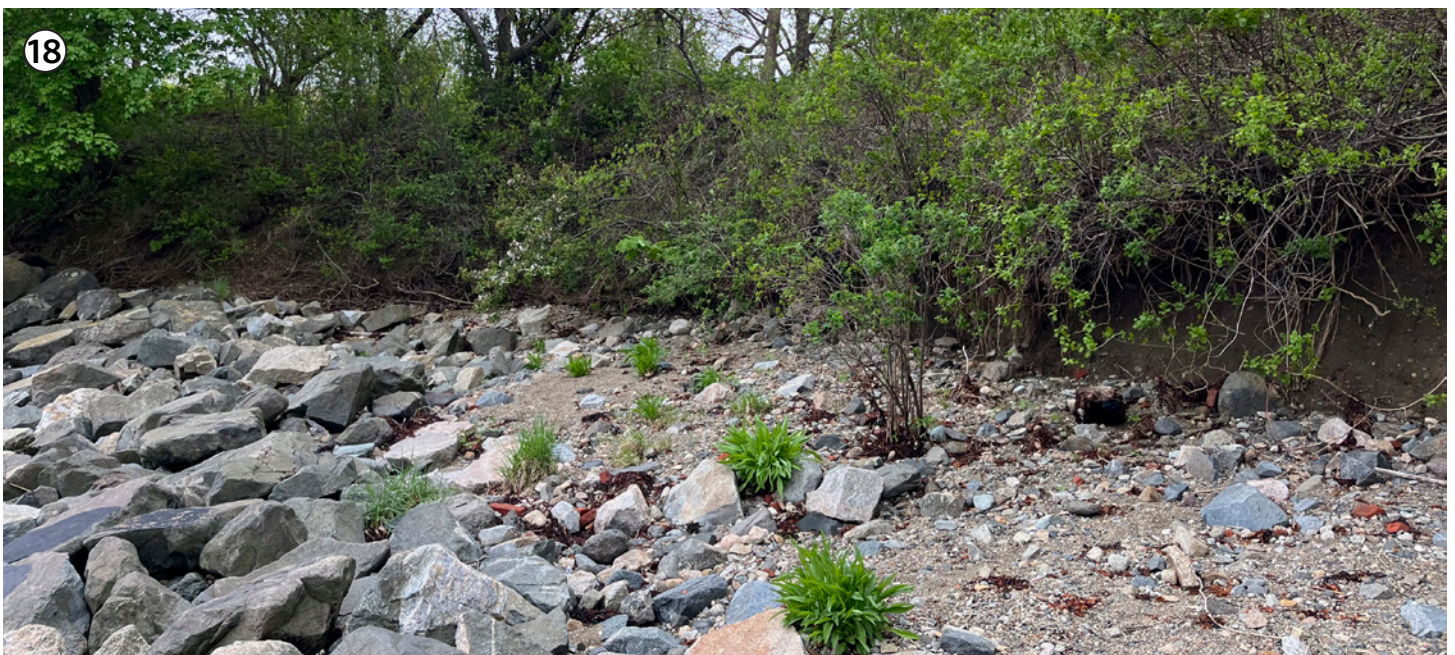
The Coastal Bank forms a crescent around Waikiki Beach with bank heights undulating from high to low in a northerly direction. The bank furthest to the south of the assessment area is fronted by a rubble revetment with a gap of 10-20 feet between the top of the revetment and the toe of the bank. (Figure 18) Wrack and other storm debris is present within this gap. As the bank extends north towards the primary pedestrian entrance to the beach, the bank becomes less steep and is protected by natural ledge-like rock formations that jut onto the beach.

FIGURE 18: NORTH FACING COASTAL BANK COVERED WITH INVASIVE VINES

Vegetation management recommendations include the treatment and removal of all non-native invasive plants where feasible. Including the selective removal of large sycamore maple and black locust where they are growing on or adjacent to the eroding Coastal Bank. Invasive plant management should be followed by soil stabilizing planting of native grasses and salt tolerant shrubs.
