WINTER ISLAND PARK

City of Salem, Massachusetts

Site Assessment Memorandum

June 28, 2024

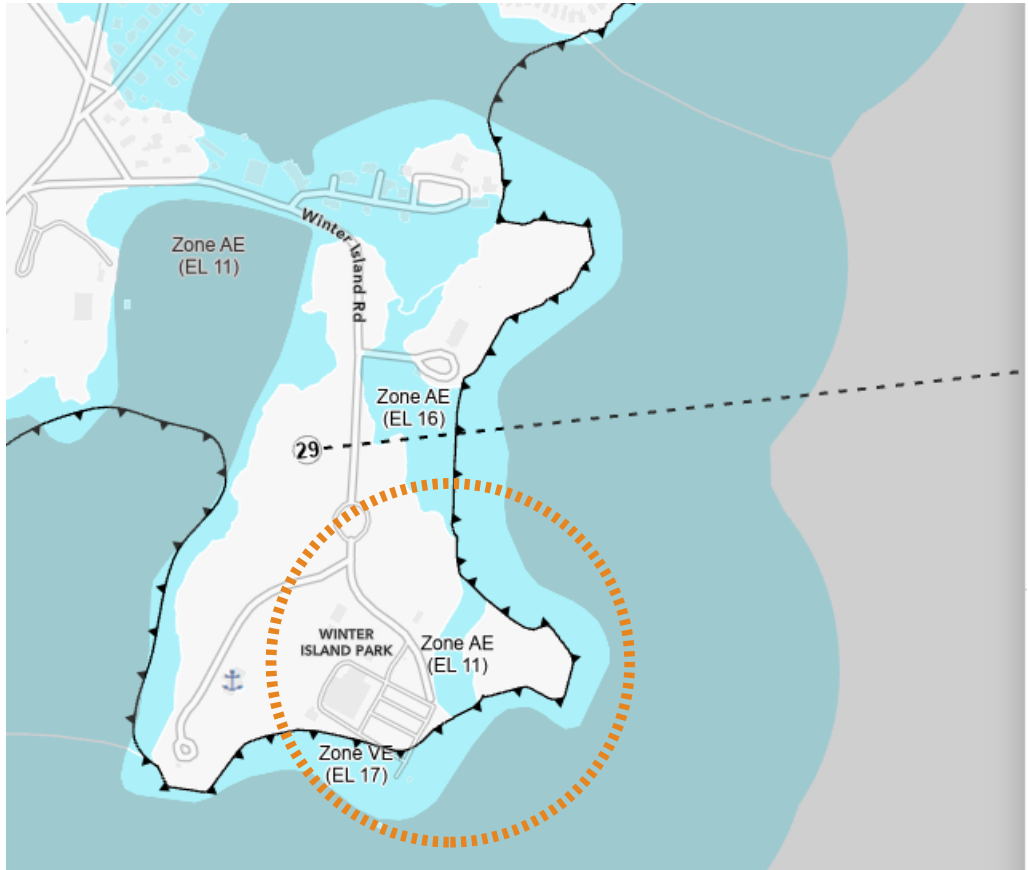
FIGURE 1: FEMA COASTAL FLOOD ZONES

This entire assessment area is within the 100-year flood zone as, defined by FEMA, which extends well into the low-lying parking area and gazebo location. The southeastern corner of the gazebo and parking area is entirely within the FEMA defined Velocity Zone (VE), which identifies areas where wave heights can reach 3' during storm events (refer to Figure 1 on page 6).

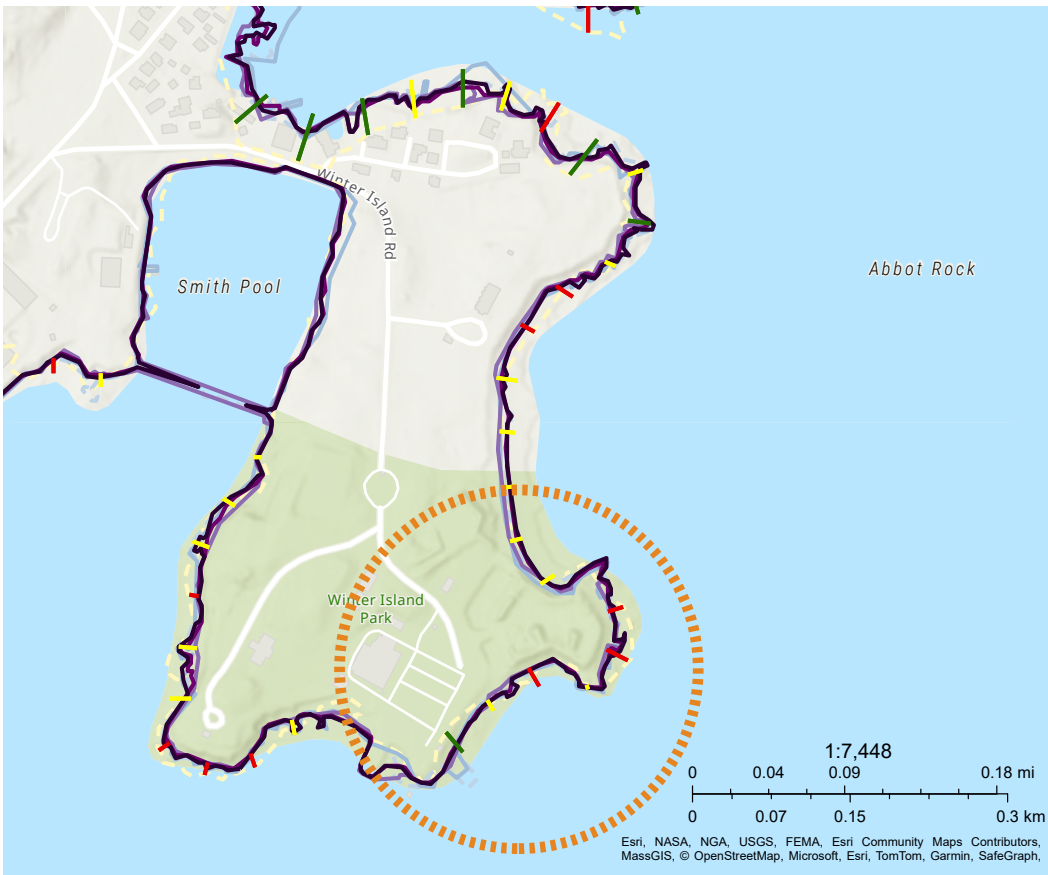
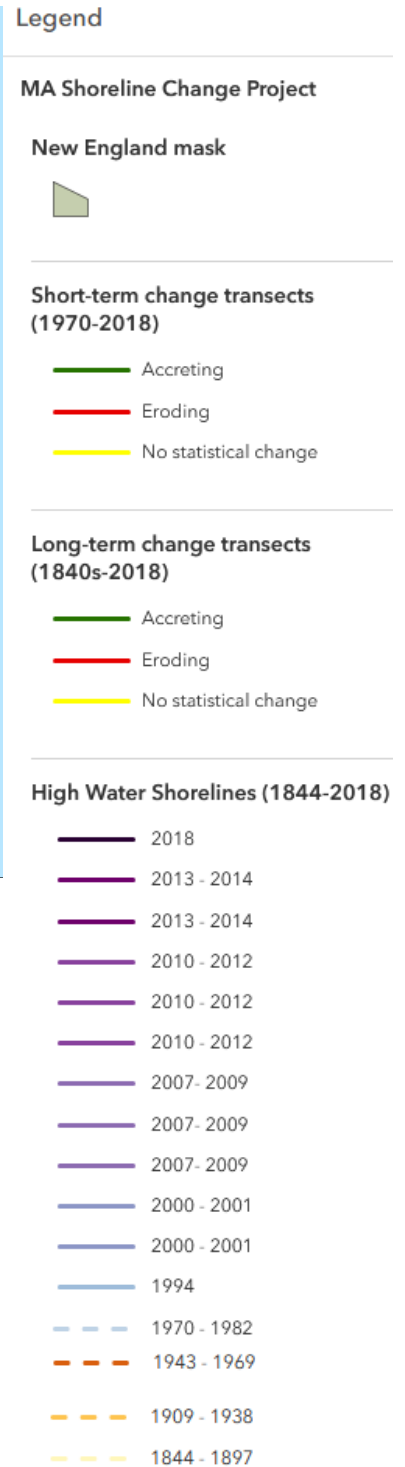
FIGURE 3: WINTER ISLAND SHORELINE CHANGE

The southwestern and central portions of the Park, and the Waikiki Beach area, in particular, are low-lying and fall within the current FEMA defined 100-year Flood Zone & Velocity Zone VE (EL. 17-feet). The topography in these areas is well below the Velocity Zone limits in most locations. These areas are likely to see continued impacts similar to those observed over the past several winters. When compounded with projected sea level rise, the probability of impacts from flooding and storms increases exponentially across the entire shoreline of the Park, with the likelihood of impacts to inland infrastructure and the higher elevation portions of the site increasing over time.

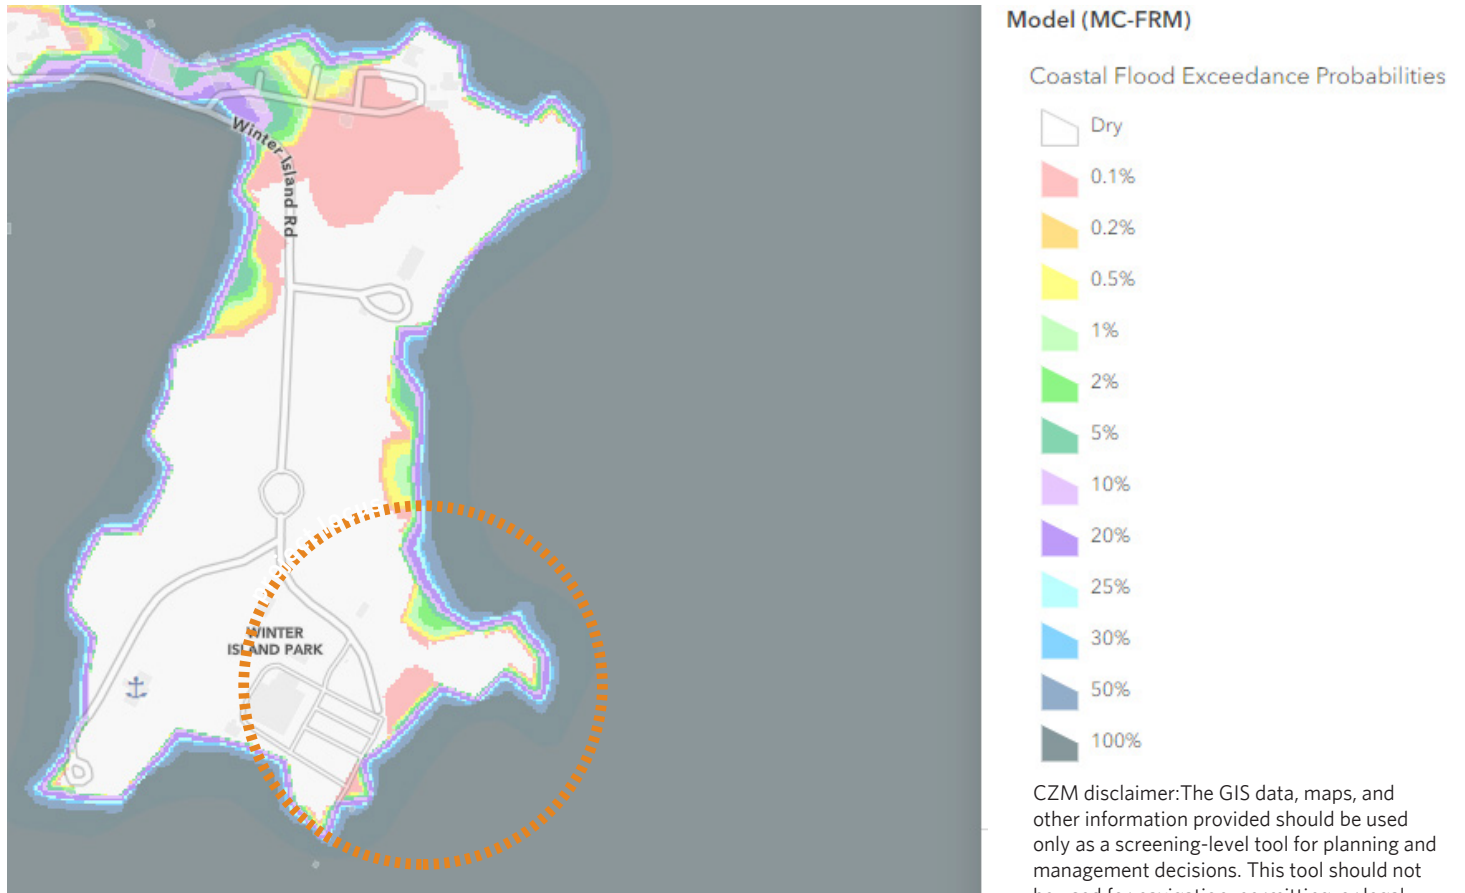
FIGURE 4: FLOOD EXCEEDANCE PROBABILITIES 2030

The maps above and to the left (*Figures 4-6*), were generated by the Sea Level Rise and Coastal Flooding Viewer from the Massachusetts Office of Coastal Zone Management (CZM). These maps illustrate the projected probability of flooding in Winter Island Park in the near future of 2023, and over the longer term of 2050 and 2070. These scenarios include the presumption of continued sea level rise due to greenhouse gas emissions and storm events.

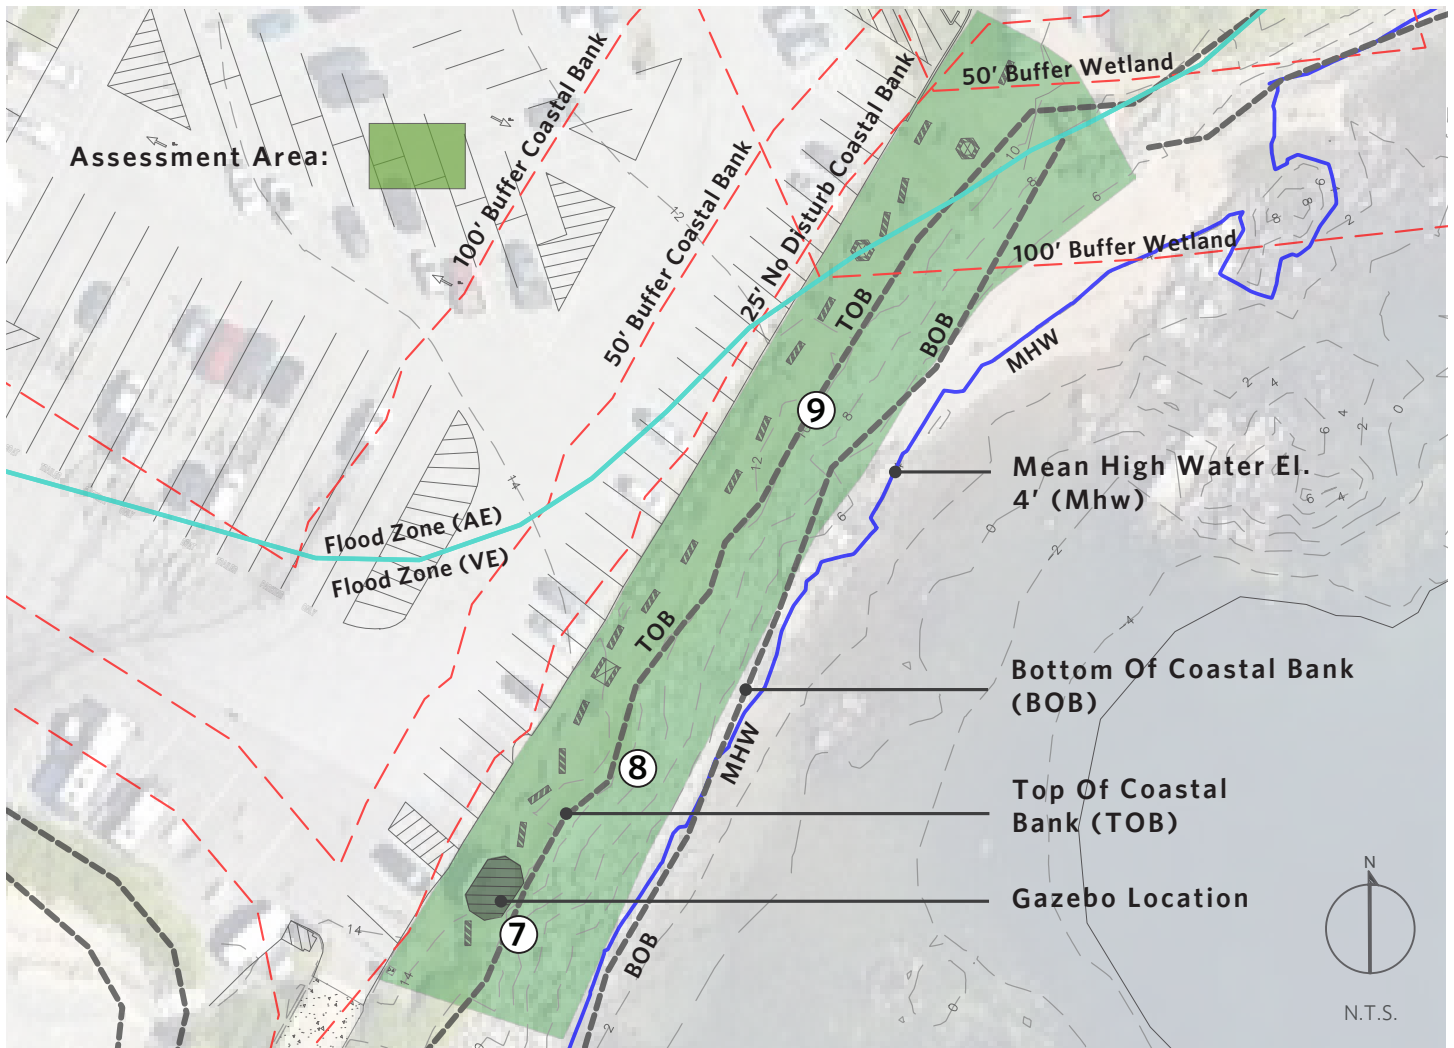
Parking Lot Edge Assessment Area

The Coastal Bank that runs the east facing length of the parking lot is undercut at an almost vertical angle. The root systems of the existing turf grass that grows at the top of the bank, and extends to the parking lot edge, are exposed at the seaward edge with sections of the bank having slumped or been completely eroded away (Figure 9).

The existing stones that comprise the lower bank have been subject to storm surge and extreme high tides during the winter and spring storms of 2023 & 2024 and will likely offer little protection to the existing parking lot and undermined gazebo foundation (Figure 7) in the near future. The undulating 20' wide grass strip extends from the top of the bank to the edge of the parking lot is also heavily compacted by foot traffic, reducing the likelihood that existing vegetation can withstand the impacts of extreme tidal conditions.

There is a limited amount of Asiatic bittersweet (*Celastrus orbiculatus*) growing at the eroded edge of the mown grass strip adjacent to the parking lot and between the revetment stones (Figure 8). It is recommended that Asiatic bittersweet in this area be treated and removed prior to implementing any erosion control strategy so that this invasive plant does not take root in any future erosion control solutions or planting.

The grass species that comprise the mown strip along the parking lot are likely a mix of non-native turf grass and self seeded native grasses. Management recommendations included establishing a no-mow buffer of deep-rooted and salt tolerant native grasses that can hold soils more effectively than shallow-rooted grasses and are more resilient to salt water over-wash. Though this area is well utilized by the public, WED recommends that foot traffic be restricted from as much of this area as possible, while native grasses are establishing. This could be accomplished with the installation of symbolic fencing, or other systems similar to what is used at the nearby Collins Cove salt marsh restoration. Shoreline stabilization measures, other than planting, will likely be required to stabilize and retain the Coastal Bank in this area and to protect the parking lot from future flooding. Planting should be performed in conjunctions with other shoreline stabilization methods that will retain soils until the root systems of the plantings become established.

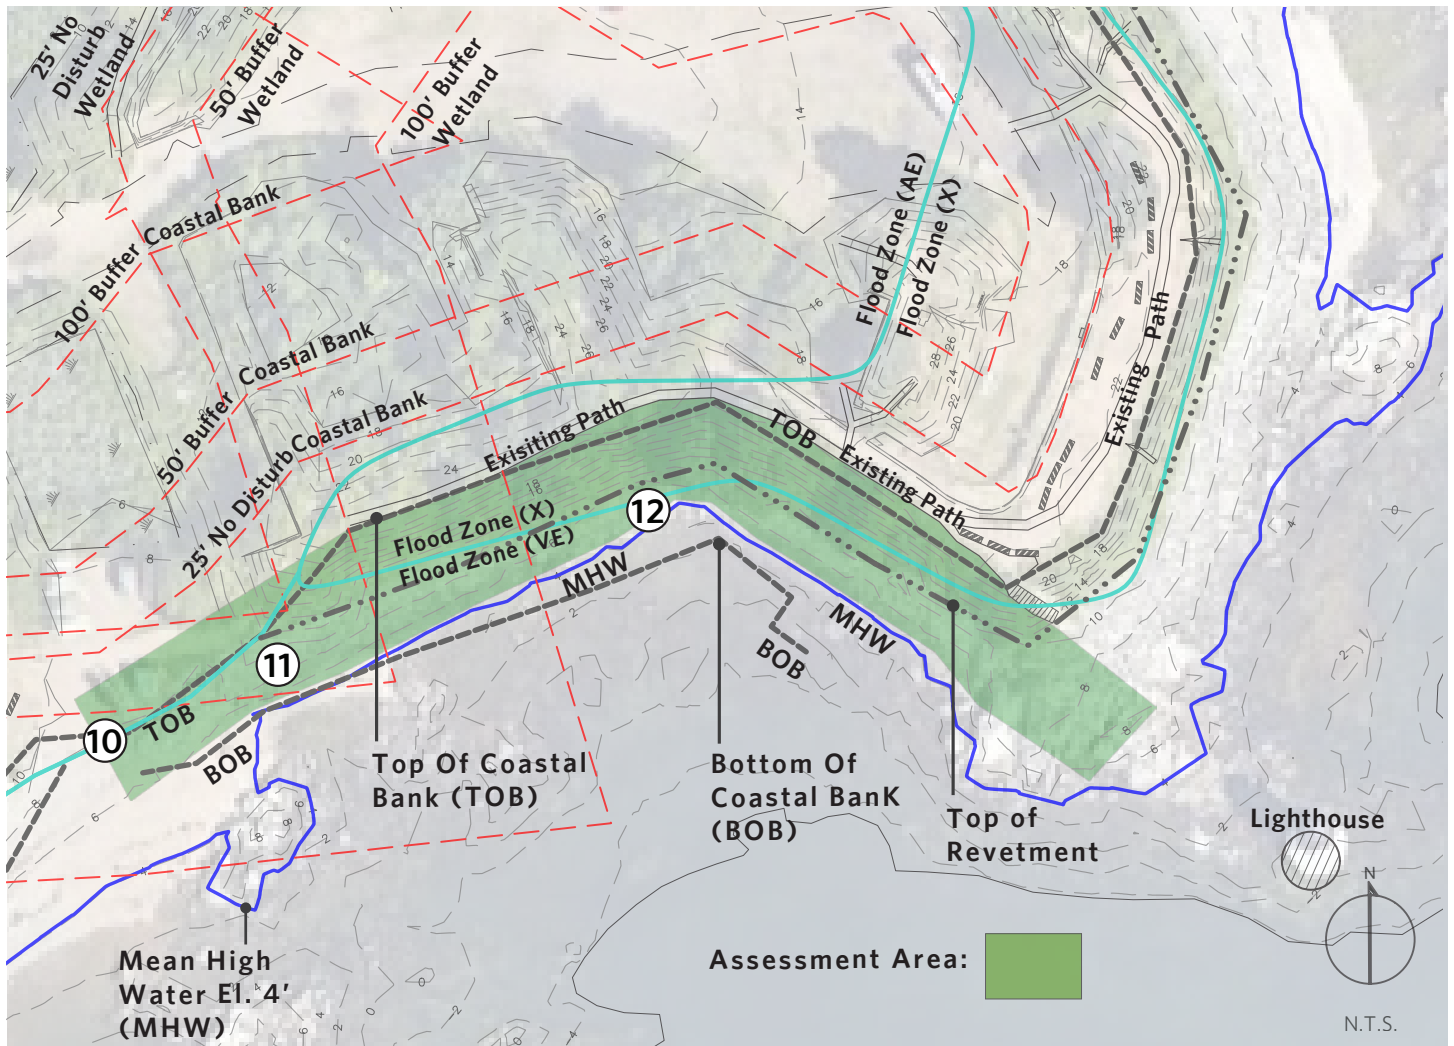
Southern Shoreline Assessment Area

The southwestern corner of the assessment area, just beyond the seasonal kayak rack and existing pathway, is the most heavily eroded portion of this area. The lower half of the pathway and bank has been stripped to bare soils with the exposed roots of Asiatic bitterweet and staghorn sumac trailing onto the lower bank (*Figure 10*). The eroded entrance to the pathway is likely due to a combination of soil compaction from foot traffic and the flooding conditions present during storm events. Portions of the lower bank adjacent to the pathway have begun to slump onto the flat area just above the revetment (*Figure 11*).

Vegetation management recommendations include the treatment and removal of Asiatic bittersweet from the entire area. Consideration should also be given to the selective removal of Sycamore maple trees (*Figure 12*). Sycamore maple is a significant invasive tree species observed throughout Massachusetts. This species' dense foliage and growth habit can significantly impact native forest understory stratification. Sycamore maple trees spread rapidly at maturity because of the large volume of seeds produced. In addition, Sycamore maple also exudes allelopathic chemicals that inhibit the growth of surrounding vegetation. In addition, large trees on steep banks can destabilize large portions of the bank if they topple. After invasive plant management is complete, planting of appropriate native grasses and shrubs on the bank is critical to establishing the deeply rooted biomass that will help retain bank soils during storm events, and to discourage the re-colonization of invasive and unwanted plants by limiting the resources available to such plants (i.e. sunlight, nutrients, and growing space).

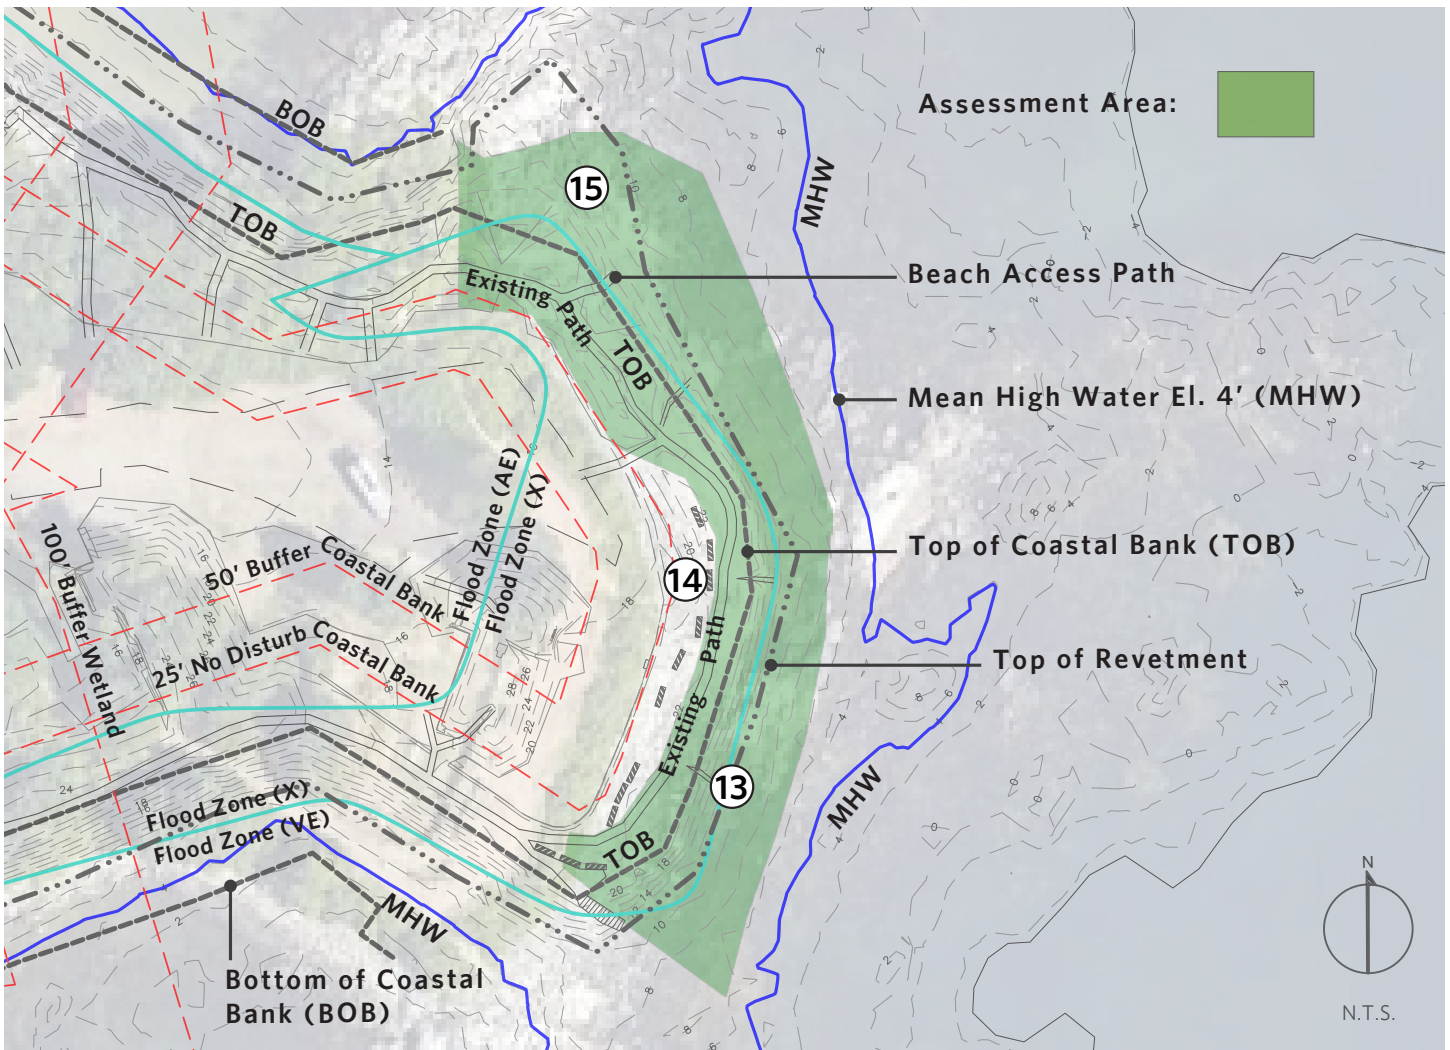
THE HEADLAND ASSESSMENT AREA

As the shoreline wraps around to the point to the north, the Coastal Bank becomes steeper (*Figure 15*). Bare soils under a dense thicket of invasive vines are present across the whole northern bank, with scarping present at several points across the bank. The wrack line is present just above the revetment at the base of the unarmored bank. A well-worn pathway cuts from the top of the bank to the beach below and a limited amount of herbaceous vegetation was observed to be stabilizing soils at the bottom of the pathway.
